Update to CR 13-04: Best Practices for Protecting DOT Equipment from the Corrosion Effect of Chemical Deicers

Final Report

**Project 1047787/CR21-02
July 2024**

Pooled Fund #TPF-5(353)
www.clearroads.org

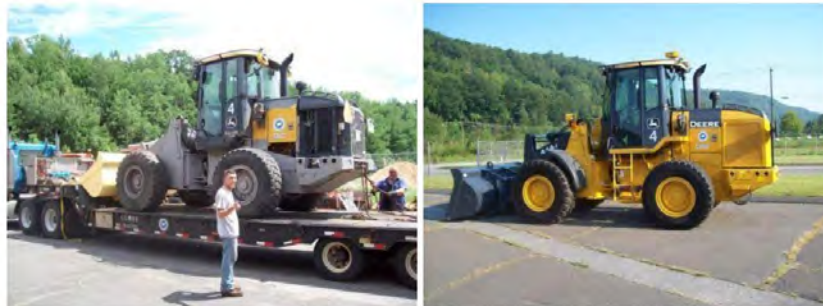
Figure 1.1 DOT vehicles - Sand blasted, had a primer coat and then painted (Honarvar Nazari et al., 2015)

Section 5.4 of the manual in the 2015 Clear Roads Project 13-04 publication (Honarvar Nazari et al., 2015) provides guidance on the use of coatings for corrosion control and protection of DOT equipment, with the focus mainly on sodium chloride deicer. For intricate geometries (like the bodies of DOT vehicles used in winter maintenance), electrochemical deposition as a coating method is effective. It is generally understood that thicker coatings would last long, but it is not the case every time. An aluminum coating only ~2 μm thick would last longer than a ~10 μm cadmium or chromium coating on steel. Notably the coating's performance hinges on how well the surface is prepared prior to coating, as nearly three-fourth of coating failures occur due to poor surface preparation. The surfaces prior to the coating must be free of contaminants. Sand or grit blasting is the most efficient surface preparation technique (see Figure 1.1), and salt removers may be used as an alternative. Rust converters are helpful when the surface to be coated, is badly rusted. They can replace the less effective surface preparation methods (such as hand or mechanical wire brushing) and may also act as a primer coat prior to the coatings. A successful plan for painting a vehicle's body may include surface blasting, use of primers and then application of a top coat with a suitable thickness. Total thickness of all coats should not be less than 8 mm (Honarvar Nazari et al., 2015).

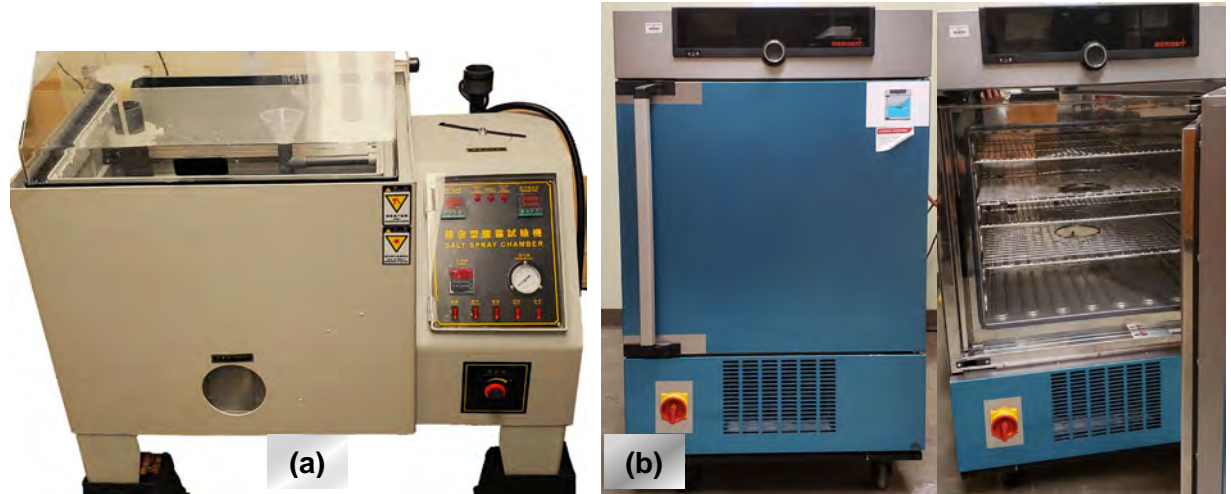
Figure 2.8 Equipment used to conduct SAE J2334 (a) Salt spray chamber, 110L capacity (110V) (b) Humidity chamber (Memmert, USA, LLC®) for humid and dry cycles

Conditions	Cycles	Values
Humid Cycle – 6 hours		
Temperature (° C)		48 – 50° C
Relative humidity (R.H., %)		85 – 95 %
Time of exposure (T, hr)		6 hrs.
Ramp time – Humid cycle and salt exposure cycle		20 min
Salt Exposure Cycle – 15 minutes		
Temperature (° C)		35° C
Relative humidity (R.H., %)		95 – 99 %
Time of exposure (T, hr)		0.25 hr. (15 min)
Ramp time – Salt exposure cycle and dry cycle		20 min
Dry Cycle – 17 hours		
Temperature (° C)		60° C
Relative humidity (R.H., %)		50 %
Time of exposure (T, hr)		17 hrs.
Ramp time – Dry cycle and humid cycle		15 min

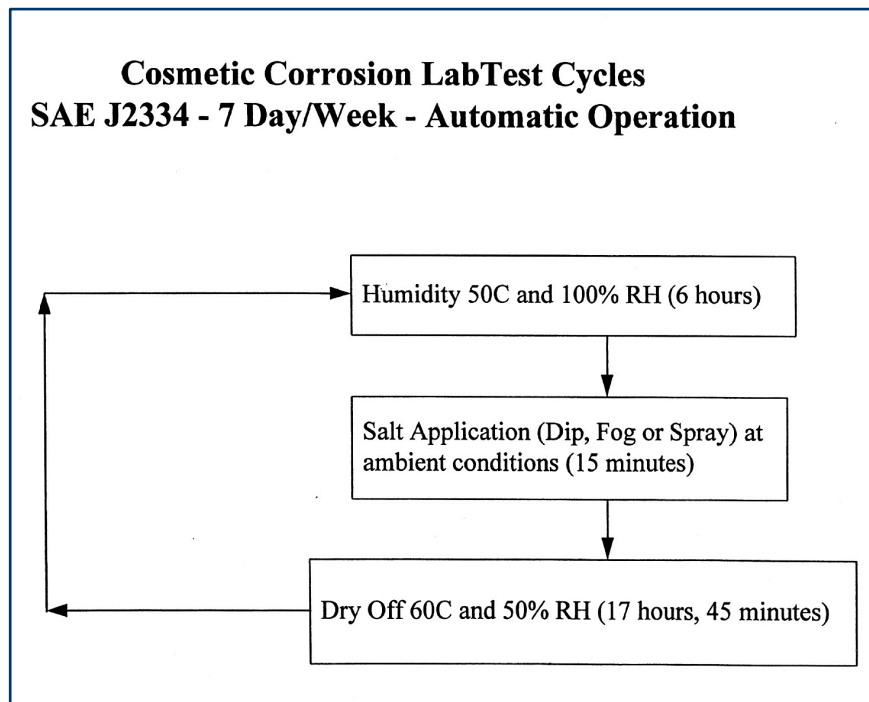
Figure 2.9 SAE J2334 daily test cycles for automatic operations (including weekends) (J2334_201604, n.d.)

SAE J2334 salt spray test is a cyclic test procedure, which requires a pre-defined number of cycles to be completed for evaluating a coating’s performance against corrosion. Each cycle lasts about a day and involves three different stages – The humid cycle, the salt spray cycle, and the dry cycle. The cycles are shown in Figure 2.9. The standard test method (SAEJ2334) is an accelerated test that indicates a minimum exposure for the coupons scribed or un-scribed should be 60 cycles or days (SAE International, 2016), which would be equivalent to 5 years of real-life exposure.

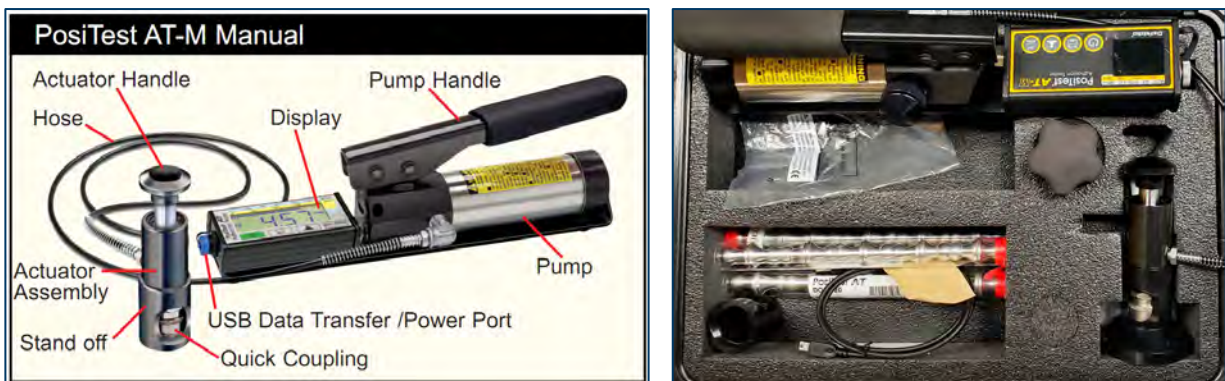
Figure 2.11 PosiTest® AT-M pull-off adhesion tester to conduct ASTM D4541 (*Instruction Manuals / DeFelsko, n.d.*)

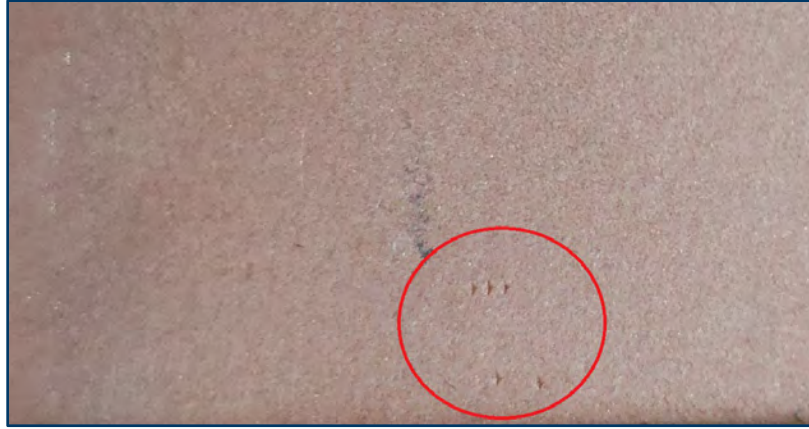
Figure 2.14 Micro indentations made on the S-AP coupon, after the Vickers hardness testing

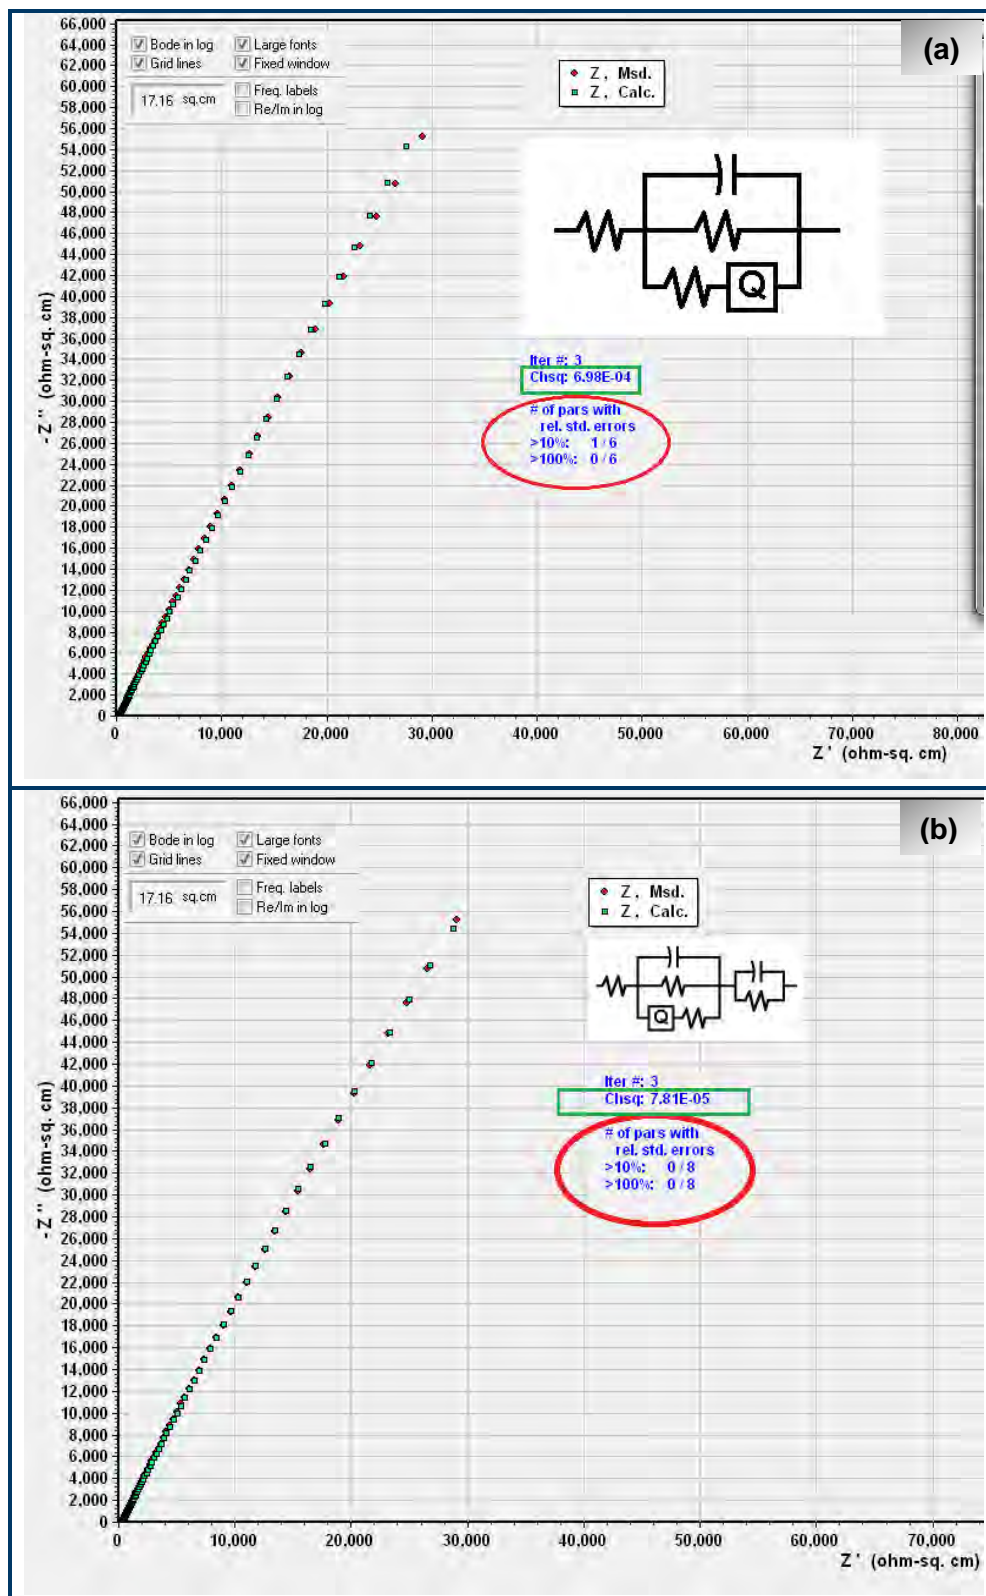
Figure 2.16 Modeled EIS Nyquist plots for SS-AS-2 days-NaCl |CaCl₂ blend salt brined: (a) Higher χ^2 (chsq) and errors (b) lower χ^2 and reduced errors

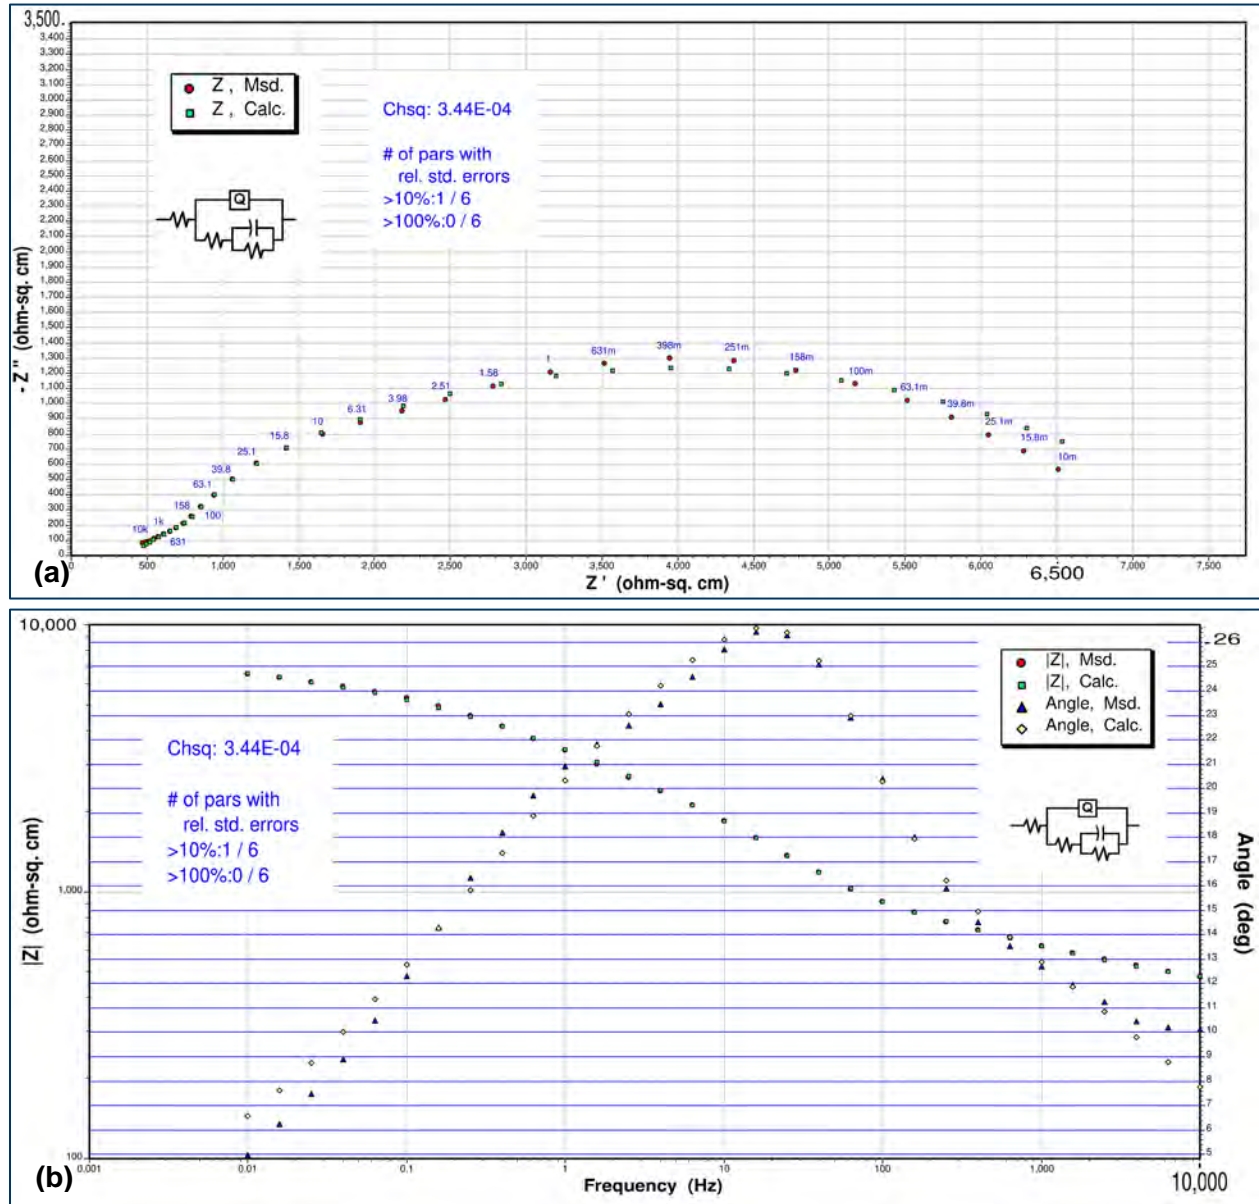
Figure 3.2 EIS modeled plots for S-LS-C-day 30, in NaCl-CaCl₂ blend (a) Nyquist plot (b) Bode plots

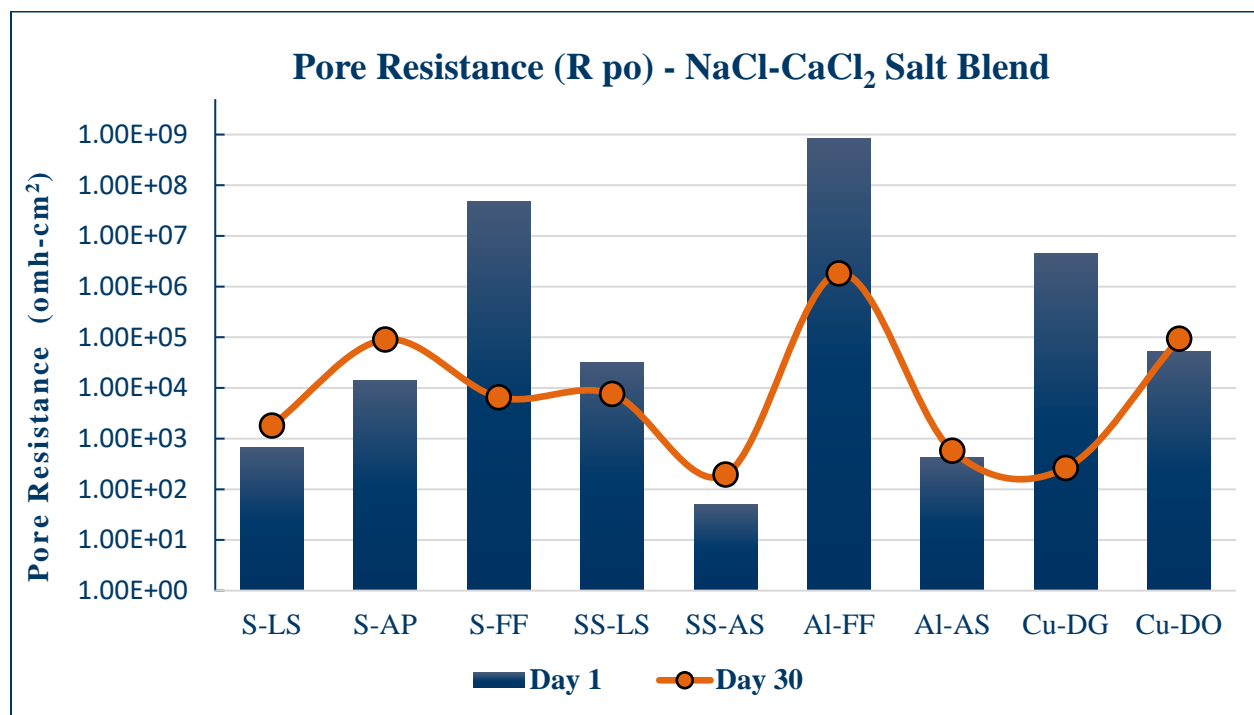
Figure 4.1 Pore resistances for day 1 and day 30 for all combinations tested in NaCl-CaCl₂ blend salt brine

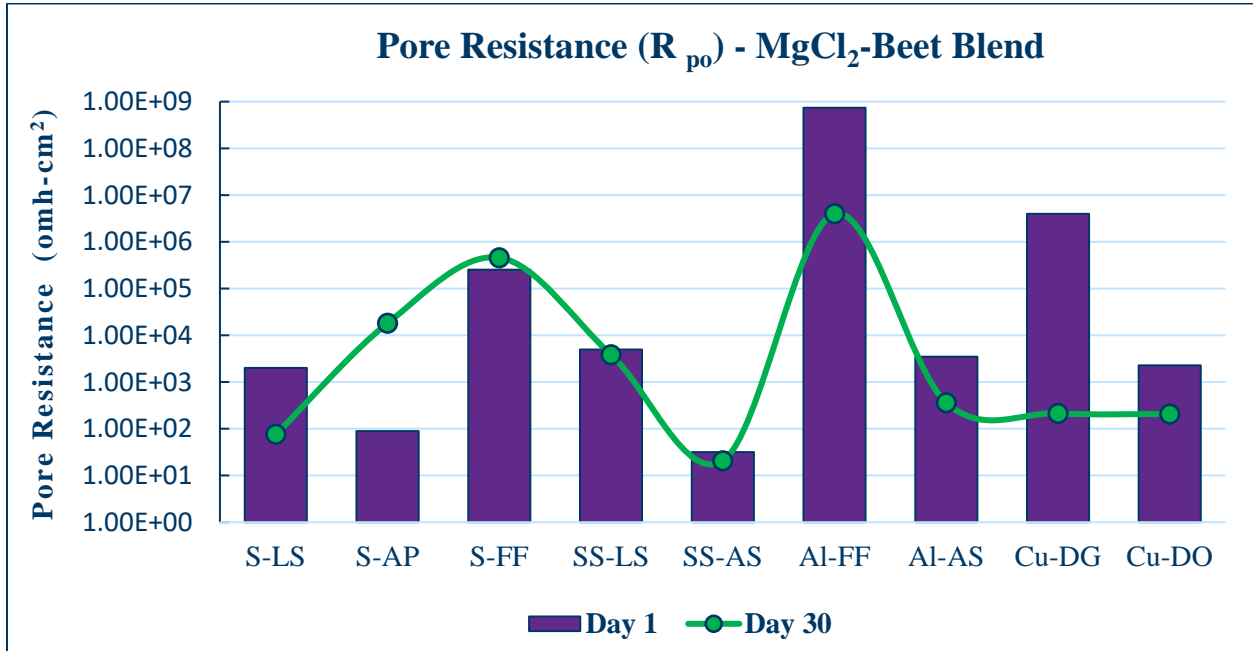
Figure 4.2 Pore resistances from day 1 and day 30 for all combinations tested in $MgCl_2$ -Beet blend

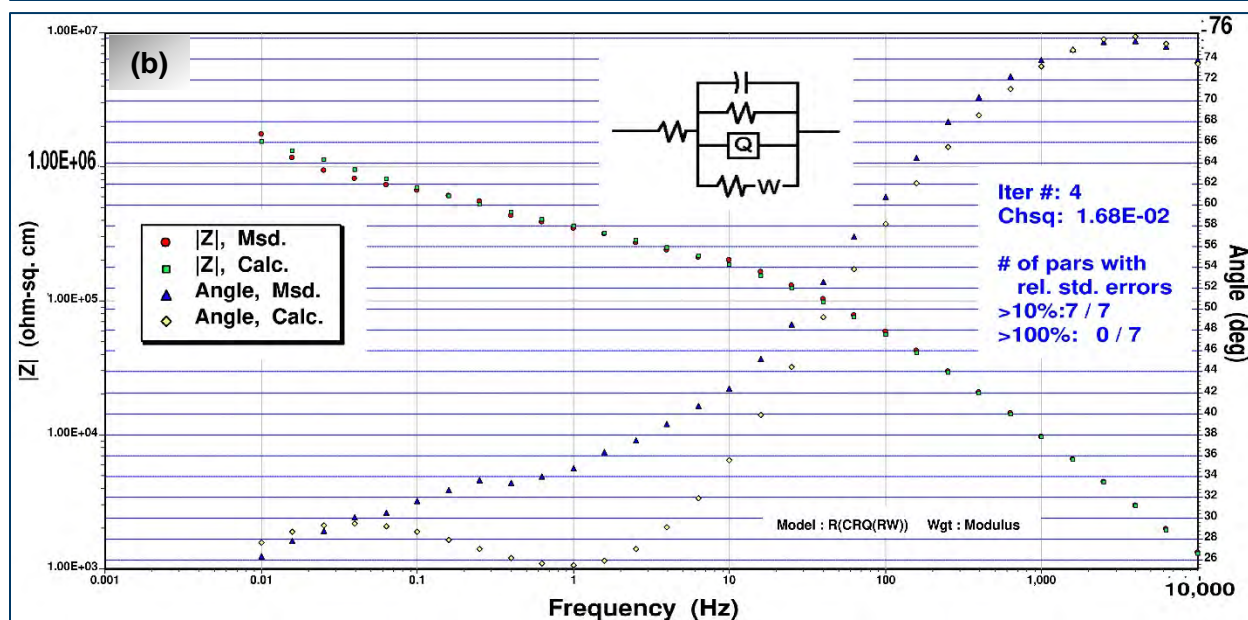
Figure A 13 EIS modeled plots for Cu-DG-B-1Hr, in NaCl-CaCl₂ blend (a) Nyquist plot (b) Bode plots

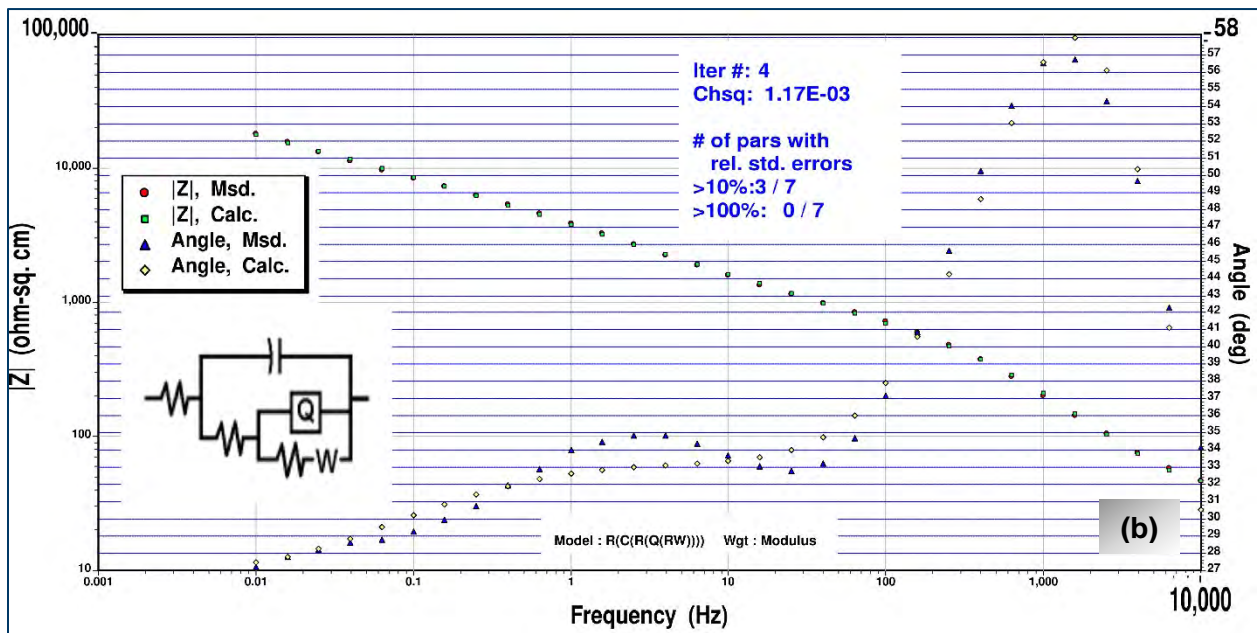
Figure A 14 EIS modeled plots for Cu-DG-B-30D, in NaCl-CaCl₂ blend (a) Nyquist plot (b) Bode plots

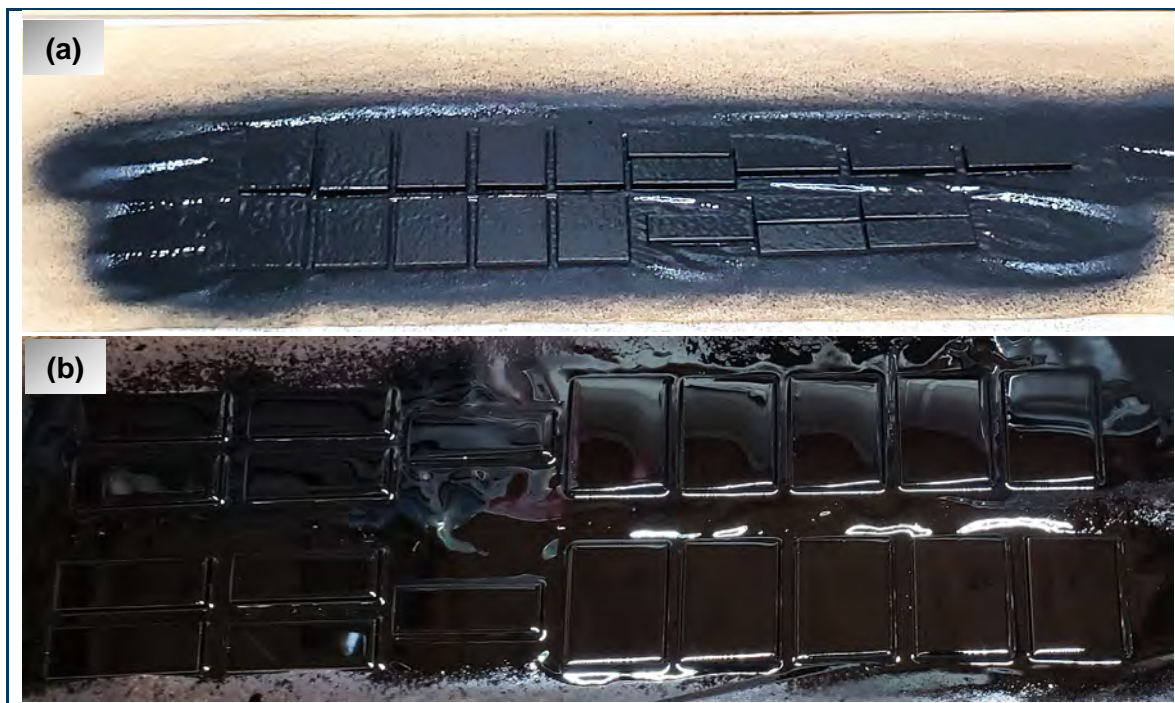
Figure C 2 Paint shop highlights: (a) Armour Seal and (b) Lubra Seal, both applied using pistol grip spray gun

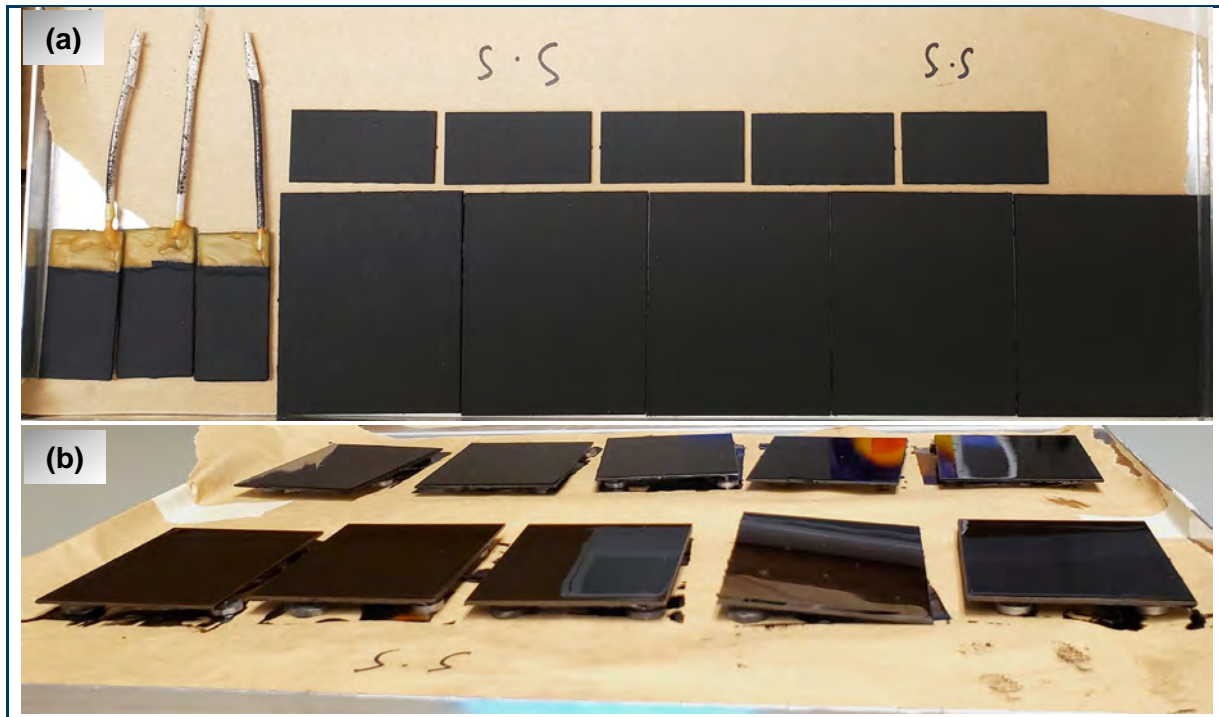
Figure C 3 Paint highlights: (a) Armour Seal dried (b) drying set up for Lubra Seal salt spray coupons

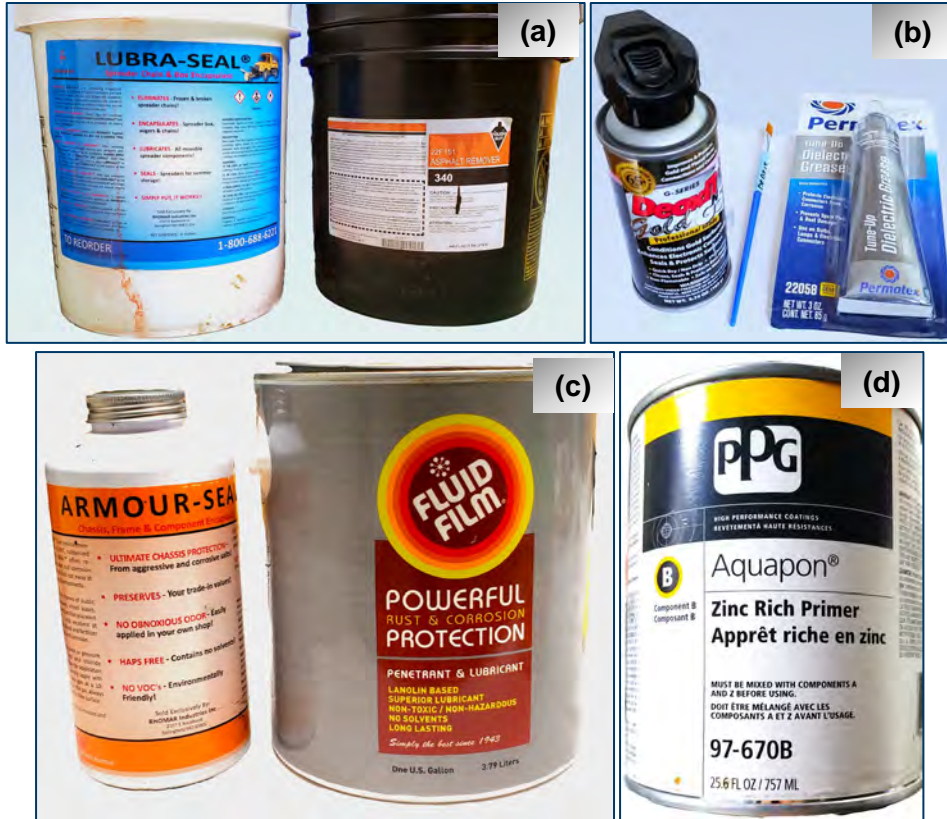
Figure C 4 Coatings used for all materials (a) Lubra Seal™ and asphalt remover (b) Deox IT® and dielectric grease (c) Armour Seal® and Fluid Film® (d) PPG Aquapon®

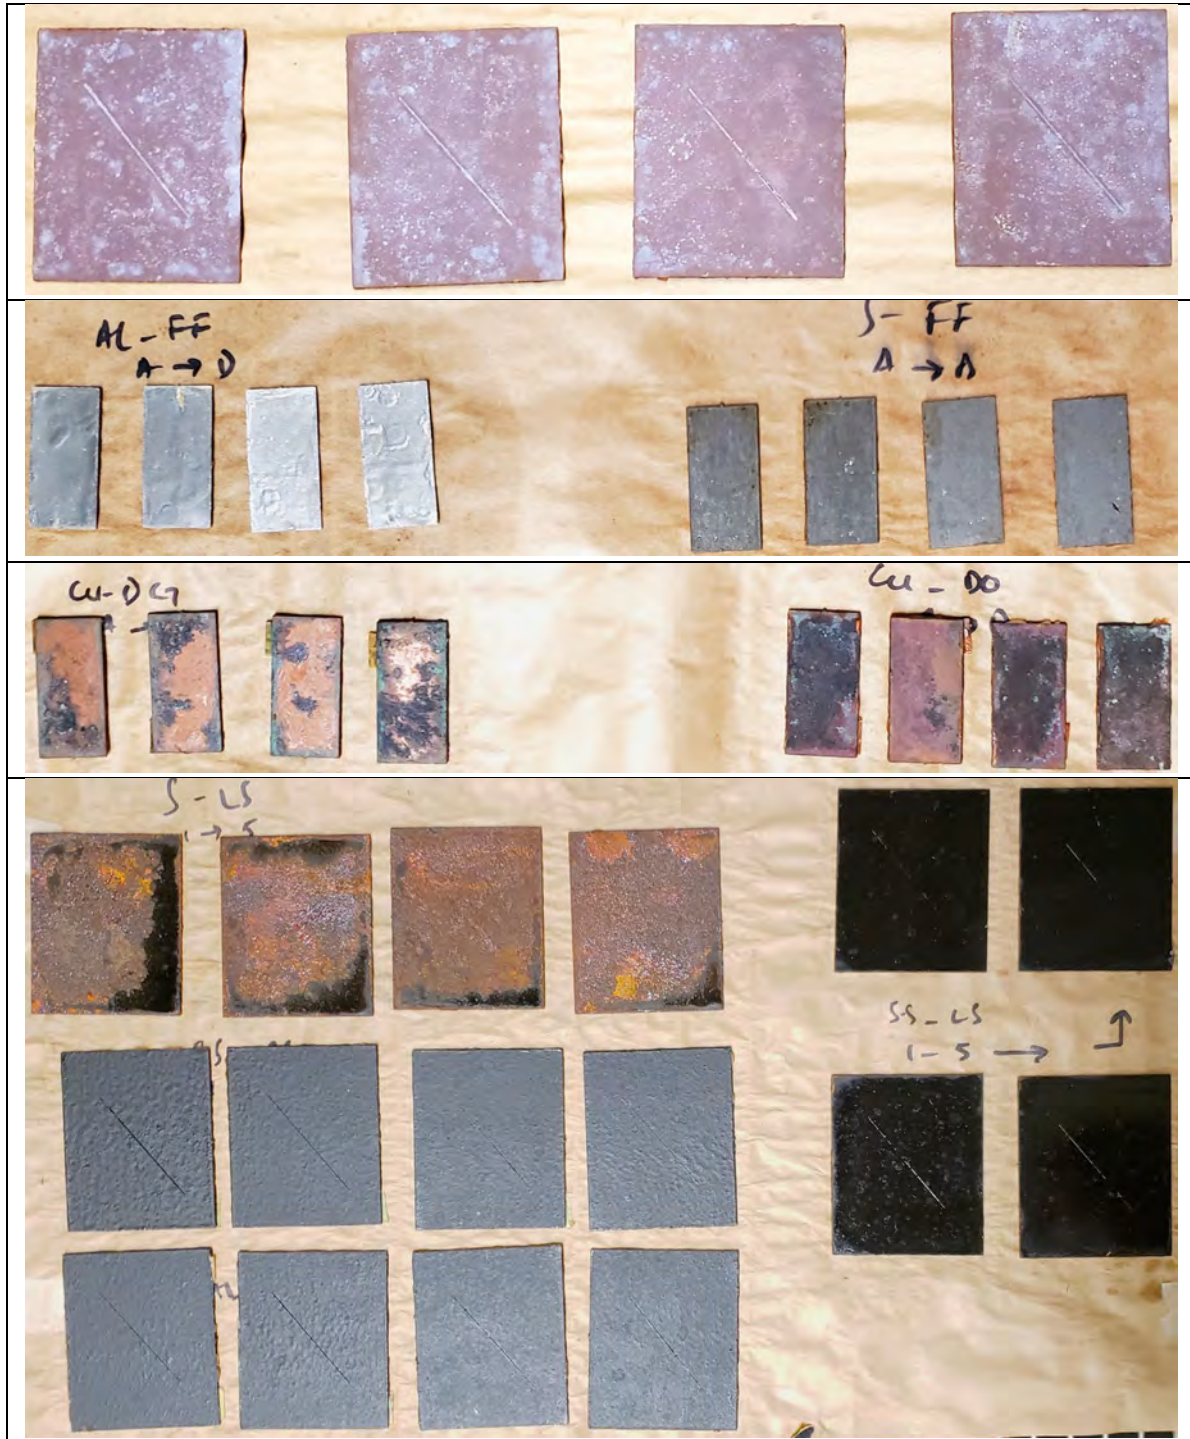
Figure C 15 Coupons for SAEJ2334 (cyclic salt spray test) – Day 60 (a) S-AP (b) Al-FF (left) and S-FF (right), (c) Cu-DG (left) and Cu-DO (right), (d) remaining scribed coupons (S-LS, SS-LS, SS-AS, Al-AS)
