Mobile Technologies for Assessment of Winter Road Conditions

SRF Consulting Group, Inc.

Project 1026091/CR16-03
March 2019

CR 16-03: Mobile Technologies for Assessment of Winter Road Conditions

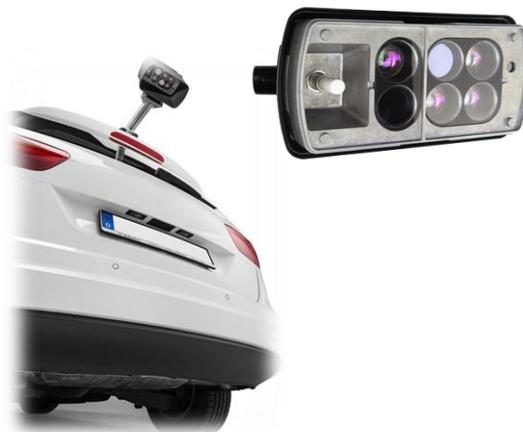
Figure 8. Lufft MARWIS

Lufft's MARWIS was released in November of 2014 with a second version released in April of 2016. Version 2.0 added the capability to collect ambient air temperature and humidity information. Other measurements taken by the MARWIS include: pavement temperature, dew point, water/ice film height, six reportable surface state conditions, and a surface friction coefficient. The six reportable surface state conditions for the MARWIS include: dry, moist, wet, ice, snow/ice, and critically/chemically wet. The critically/chemically wet condition occurs when wet conditions are detected with surface temperatures reported below the freeze point (indicating the presence of chemicals or the near possibility of ice forming).

As the MARWIS is Bluetooth enabled, the only limitation on mounting location would be the distance of a standard Bluetooth data transmission (~30 feet) and where the user is interested in collecting data. The recommended mounting height above the detected surface is 1-2 meters. If connecting to a modem or AVL system, a 15-foot cable is provided, but customizable lengths of the standard cable can be requested, as necessary. The vendor noted that sensors have been placed on the front of a vehicle or on the rear between the tires. They also noted that Michigan DOT has mounted several of these sensors on plows.

The MARWIS device operates from 12-28 VDC. In temperatures below 14°F, the vendor recommends the power supply be increased to 24V to ensure the heating performance in the sensor is adequate. The power input is 3 VA without heating, and 50 VA with heating.

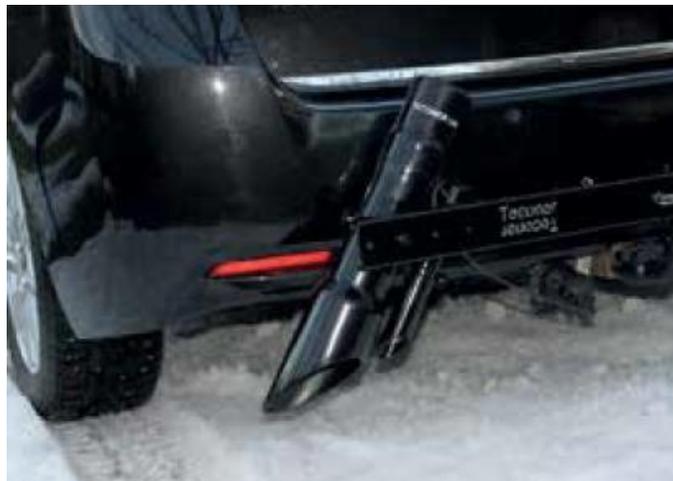
Figure 11. Teconer RCM411

Teconer's RCM411 measures pavement temperature, ambient air temperature, dew point and humidity (optional), water film height, six surface state conditions, and a friction coefficient. The six reportable surface state conditions include: dry, moist, wet, slush/ice/snow with water, ice, and snow. The mobile application tracks vehicle speed and GPS location and adds it to the recorded data.

The Teconer RCM411 operates with a power supply of 9 to 30 VDC, which can be powered from a trailer light connector or cigarette lighter in the vehicle. Its power consumption is approximately 1 watt. The operating temperature for the RCM411 is -22 to 122°F.

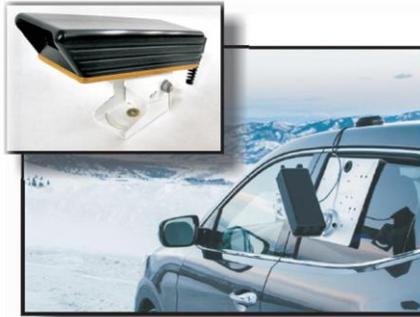
Figure 14. High Sierra Mobile IceSight

High Sierra's Mobile IceSight was first available commercially in 2013 with the most recent revision being released in 2015. The IceSight uses an open-architecture data output that includes many various parameters, including: air temperature, relative humidity, surface temperature, six reportable surface state conditions (dry, damp, wet, slush, snow, and ice), and a surface friction coefficient. While this sensor does not have internal GPS data collection capability, High Sierra has worked with several vehicle controller companies to integrate GPS data from other sources.

The voltage range for the High Sierra Mobile IceSight is 10 to 14 VDC and its power consumption is approximately 5 Watts. The operating temperature is -40 to 149°F.

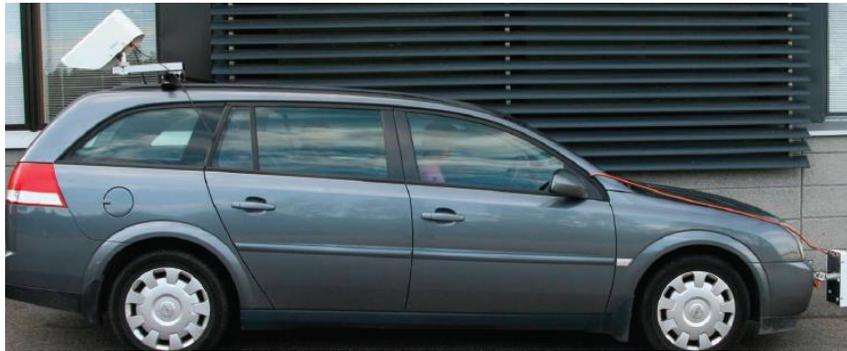
Figure 17. Vaisala DSP310

Vaisala's DSP310 is the mobile edition of its DSC-111 road weather sensor. It has the capability to measure and report five surface state conditions, the pavement surface temperature, a friction coefficient, ambient air temperature, dew point, humidity, and water/ice/snow layer thicknesses. The five reportable surface state conditions include: dry, moist, wet, snow, and ice.

The Vaisala DSP310 requires an input voltage of 10 to 33 VDC with an input current typically between 0.8-1.5A and a maximum of 10A. The power consumption ranges from 15-72W. The outside operating temperature range is -40 to 140°F with an operating relative humidity of 0 to 100%.

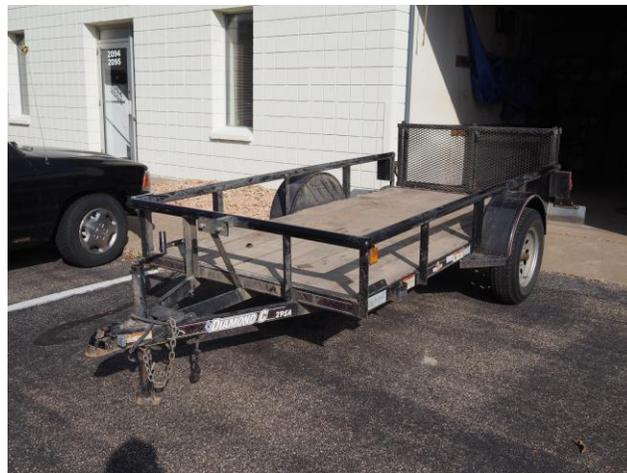
Figure 23. Trailer Without Sensors

To best accomplish the goal of comparing one sensor to another, a trailer design was developed which situated sensors in close proximity to one another so that each sensor was detecting the same area of pavement. As part of the project development and planning process for the field evaluation, it was noted that agencies would like to know more about the installation and mounting procedures required for each sensor. Since this project required simultaneous data collection of the same area for all sensors, installations on the trailer did not always match the procedures recommended by the sensor vendors. However, the proper mounting techniques and methods were followed as closely as possible with special modifications being made to the trailer to accommodate various mounting attachments.
